# Learning from Errors with the New COVID-19 Vaccines

January 14, 2021

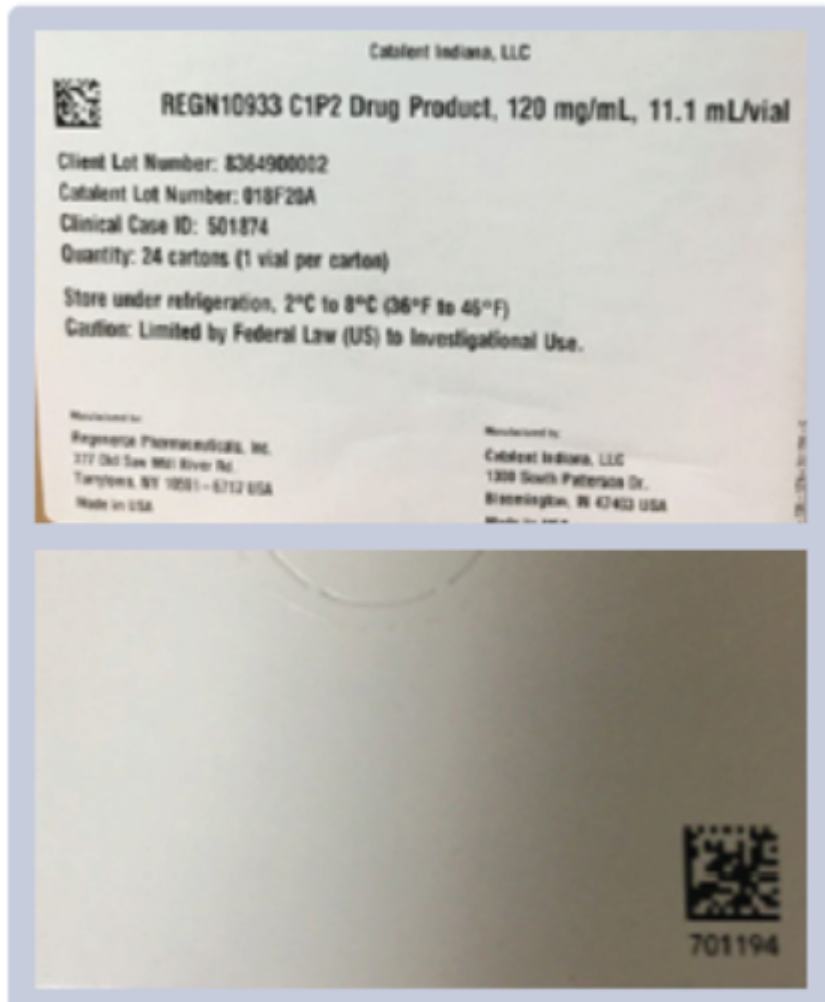
The mix-up between the Moderna vaccine and casirivimab started during the distribution process. The county health department dispatched two individuals from the National Guard to retrieve COVID-19 vaccine supplies from an area medical center for the WV clinic. When the individuals arrived at the medical center, they signed a chain-of-custody form stating that the product they were picking up was the “Moderna COVID-19 vaccine.” The small white case they were given mentioned REGN10933 (**Figure 1**), which the individuals did not recognize as a monoclonal antibody. According to media reports

([https://www.coalvalleynews.com/news/vaccine-mix-up-causes-confusion-in-boone-co/article\\_dd97f36e-4b8b-11eb-ae31-079b9036a788.html](https://www.coalvalleynews.com/news/vaccine-mix-up-causes-confusion-in-boone-co/article_dd97f36e-4b8b-11eb-ae31-079b9036a788.html)), nothing on the white case led the individuals to believe it was not the vaccine listed on the chain-of-custody form. Instead, they thought it must be special labeling for the new vaccine. The case was then transported to the clinic. Inside the case, the vial cartons and vials were, again, only labeled with REGN10933, not the product name (**Figure 2**). Unfortunately, the error was not recognized, and casirivimab was administered IM to the patients instead of the vaccine. No serious adverse reactions were reported, and patients were offered the vaccine as soon as possible.

**Figure 1.** Front (top) and back (bottom) of a case of a Regeneron monoclonal antibody, which is labeled with a product code name (REGN10933), not the established name, casirivimab.

Also, our December 3, 2020, newsletter called attention to the labeling problems with Regeneron's casirivimab and imdevimab, which clearly played a role in the mix-up. Two versions of vial and carton labels for each monoclonal antibody exist, which were used during investigational trials. Neither version includes the name of the specific antibody contained within and instead lists a product code number for casirivimab (REGN10933) and imdevimab (REGN10987). Although a barcode is on the vial label, it is not functional or tied to a National Drug Code (NDC) number. Initially, supplies of these monoclonal antibodies affixed with investigational new drug (IND) labels were used to meet the immediate demands for this COVID-19 treatment option.

**Regeneron confirms that a third version of the carton and vial label** (<https://www.regeneron.com/sites/default/files/treatment-covid19-eua-preventing-medication-errors.pdf>) meant for EUA use is now being applied to the product and hopefully will be in the field in a few weeks. These EUA-specific labels are color differentiated and include a functioning barcode. While the cap color will remain red for now given current stock, we hope the cap colors will eventually match the new label color schemes. ISMP also believes Regeneron should consider packaging a vial of casirivimab with a vial of imdevimab in a single carton, or mixing the two monoclonal antibodies in a single vial if possible, since they must be administered together.

**Identify/differentiate monoclonal antibodies.** If Regeneron monoclonal antibodies are received in investigational drug packaging without the product name on the case, vial carton, or vial (**Figures 1 and 2**, above), establish a process immediately upon receipt to identify and differentiate each antibody from other medications, including the Moderna COVID-19 vaccine. For example, the pharmacy at Beaumont Hospital in Royal Oak, Michigan, affixes brightly colored labels (pink for casirivimab, green for imdevimab) that include the product name, strength, and a scannable barcode (**Figure 4**) to provide visual distinction and verify product selection prior to preparation. NDCs are available in the Fact Sheets and can be used to prepare the barcodes.

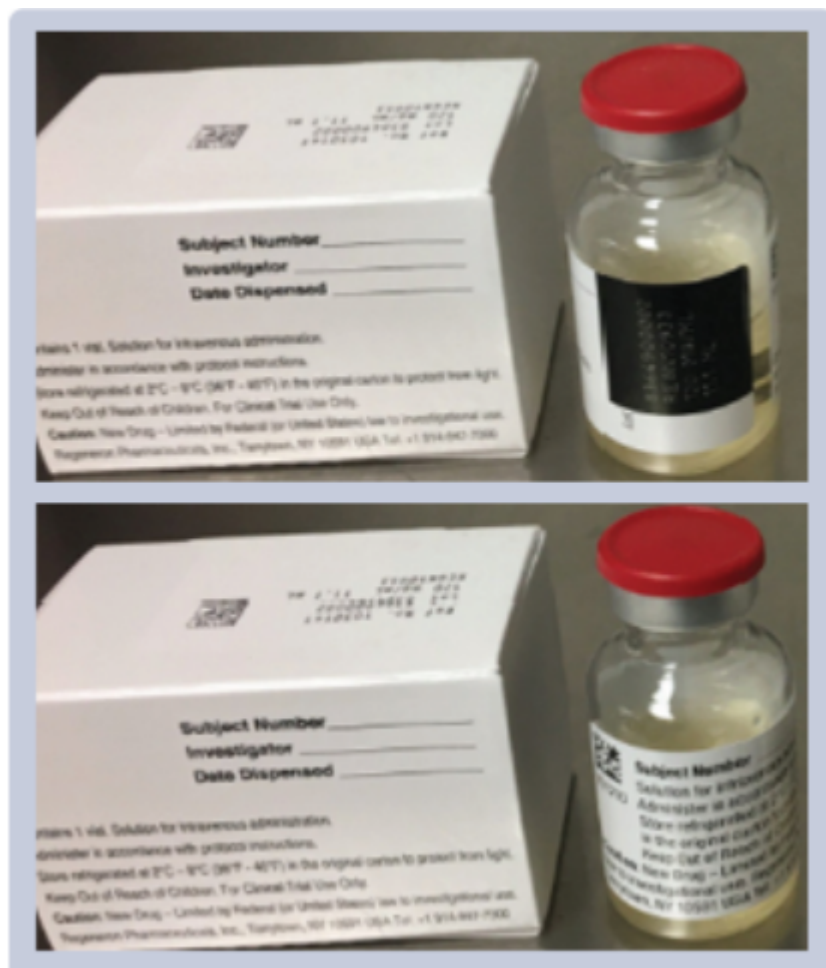
**Figure 2.** Vial carton and front (top photo)/back (bottom photo) of a vial of Regeneron's casirivimab is labeled with a product code name, not the established name.

Although we do not have a detailed description of why the error happened, product packaging and labeling issues were likely involved. Both the Moderna vaccine and the Regeneron monoclonal antibody are available in 5 mL glass vials. The vaccine vial contains 5 mL (10 doses of 0.5 mL each) while the vials of the monoclonal antibodies are partially full and contain 2.5 mL. It should be noted that both of the Regeneron antibodies (casirivimab and imdevimab) are available in larger vials containing 11.1 mL, which may have been used at the time of the error. Vials of both the Regeneron antibodies and the Moderna vaccine have identical red caps (**Figure 3**). If the clinic staff had previously administered the Moderna vaccine, they may have been expecting a vial with a red cap, similar to the monoclonal antibody, casirivimab, packaged in a vial with a red cap.

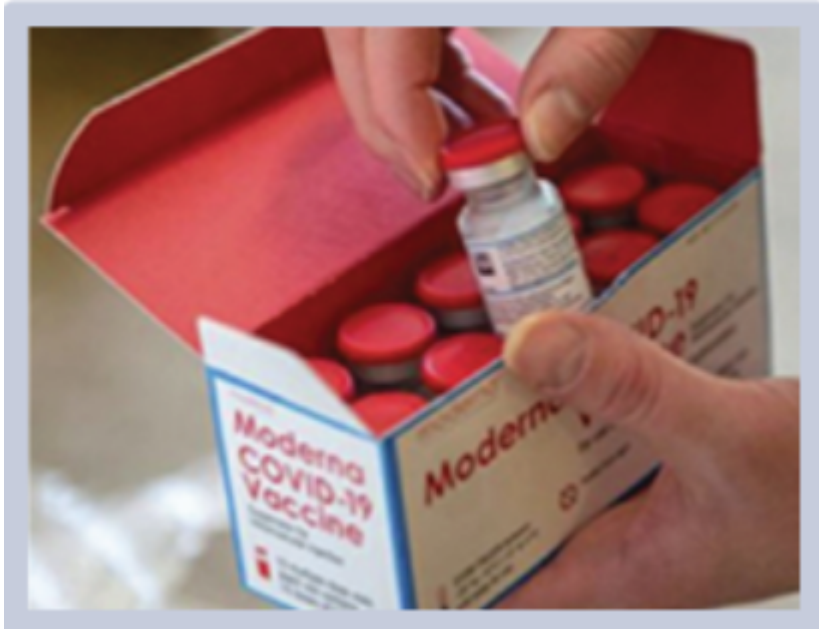
**Figure 3.** The Moderna COVID-19 vaccine vial has a red cap, similar to the red cap on vials of Regeneron's monoclonal antibodies (see **Figure 2**).

**Separate vaccine storage.** To avoid mix-ups, do not store the Pfizer-BioNTech and Moderna vaccines together in the refrigerator while or after thawing (e.g., use separate shelves). Do not place the vaccines close to the Regeneron monoclonal antibodies.

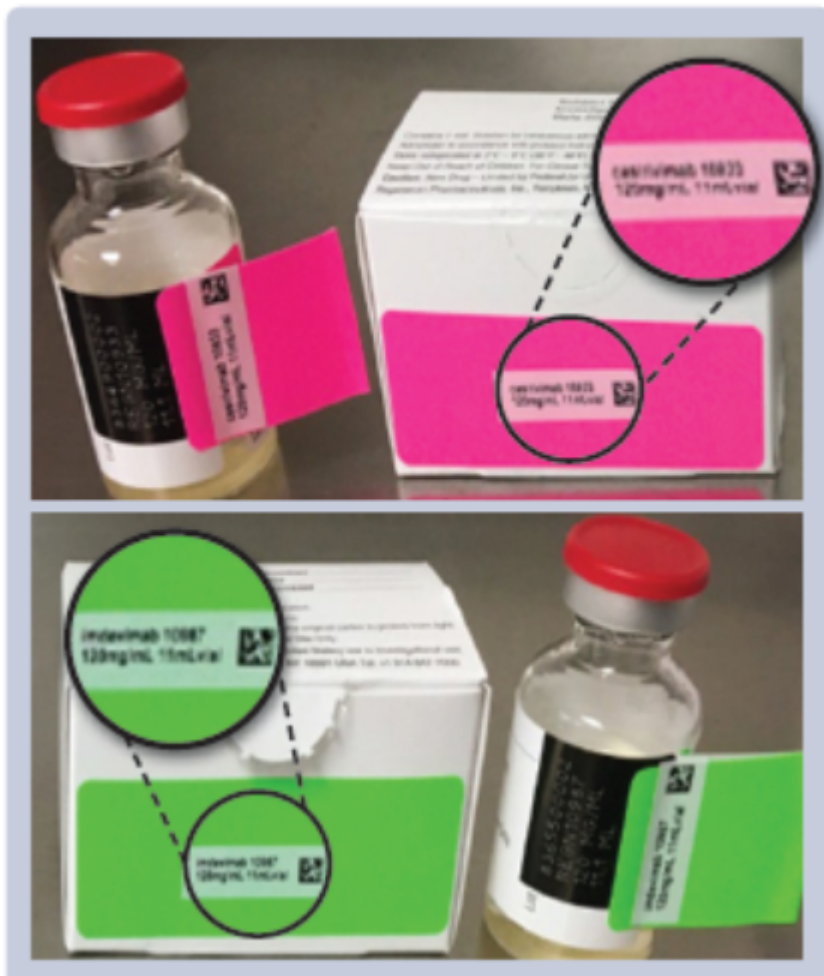
**Figure 4.** Hospital affixes barcoded, brightly colored labels to help differentiate investigational labels on casirivimab (top, pink) from imdevimab (bottom, green).
